**TIMOTHY C. BEST, CEG**  
**ENGINEERING GEOLOGY AND HYDROLOGY**

Job: MCP-BUCKFALLS-889

**SUBJECT: BUCK GULCH FALLS TRAIL BRIDGE GEOLOGIC HAZARD ASSESSMENT AND FEASIBILITY STUDY**

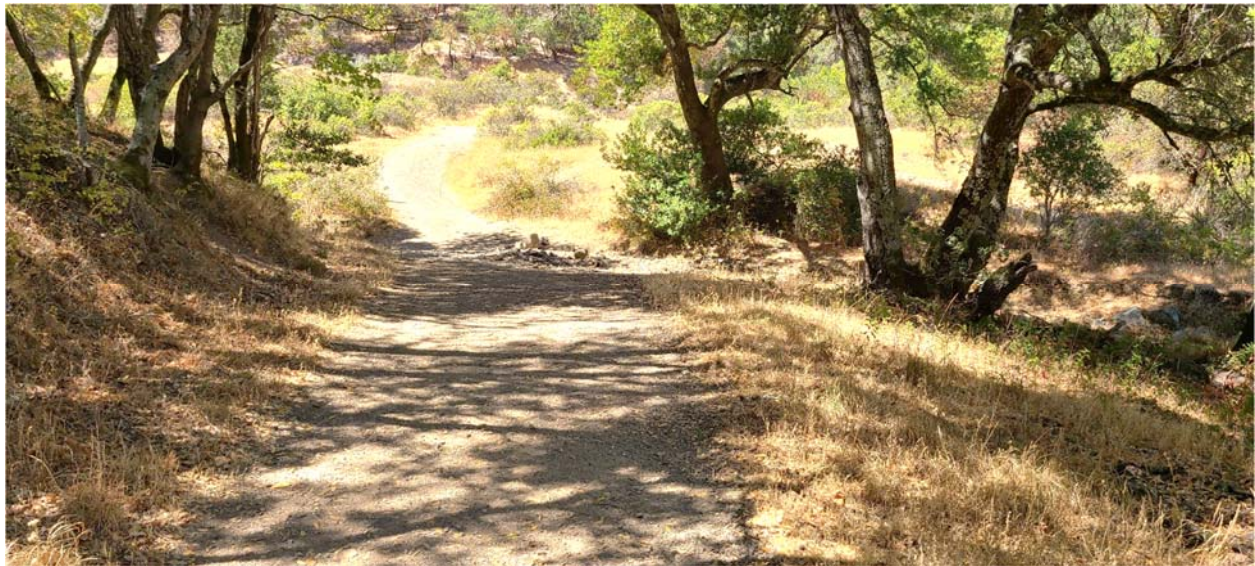
**Photo 1: Looking north across existing ford crossing**

At the ford crossing Arroyo San Jose drains a 398-acre steep forested watershed. The active stream channel is approximately 10 feet wide, gravel and cobble bedded with an average channel gradient of about 2 to 2.5% (Figure 2, Photos 1, 2 and 3).

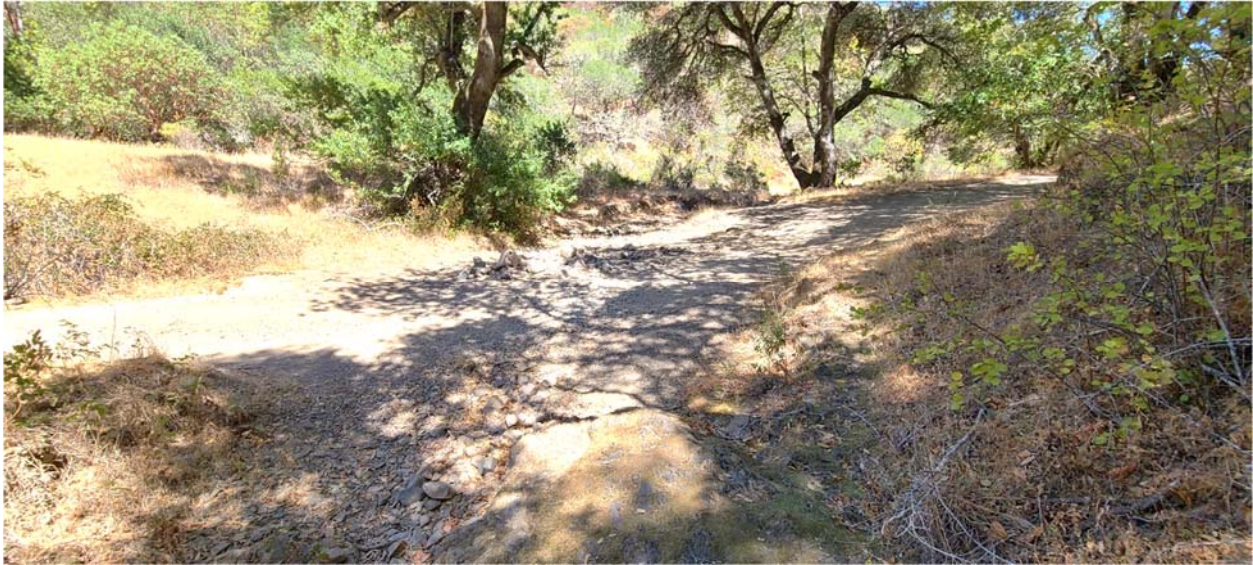
**Photo 2: Looking downstream, across existing ford crossing**

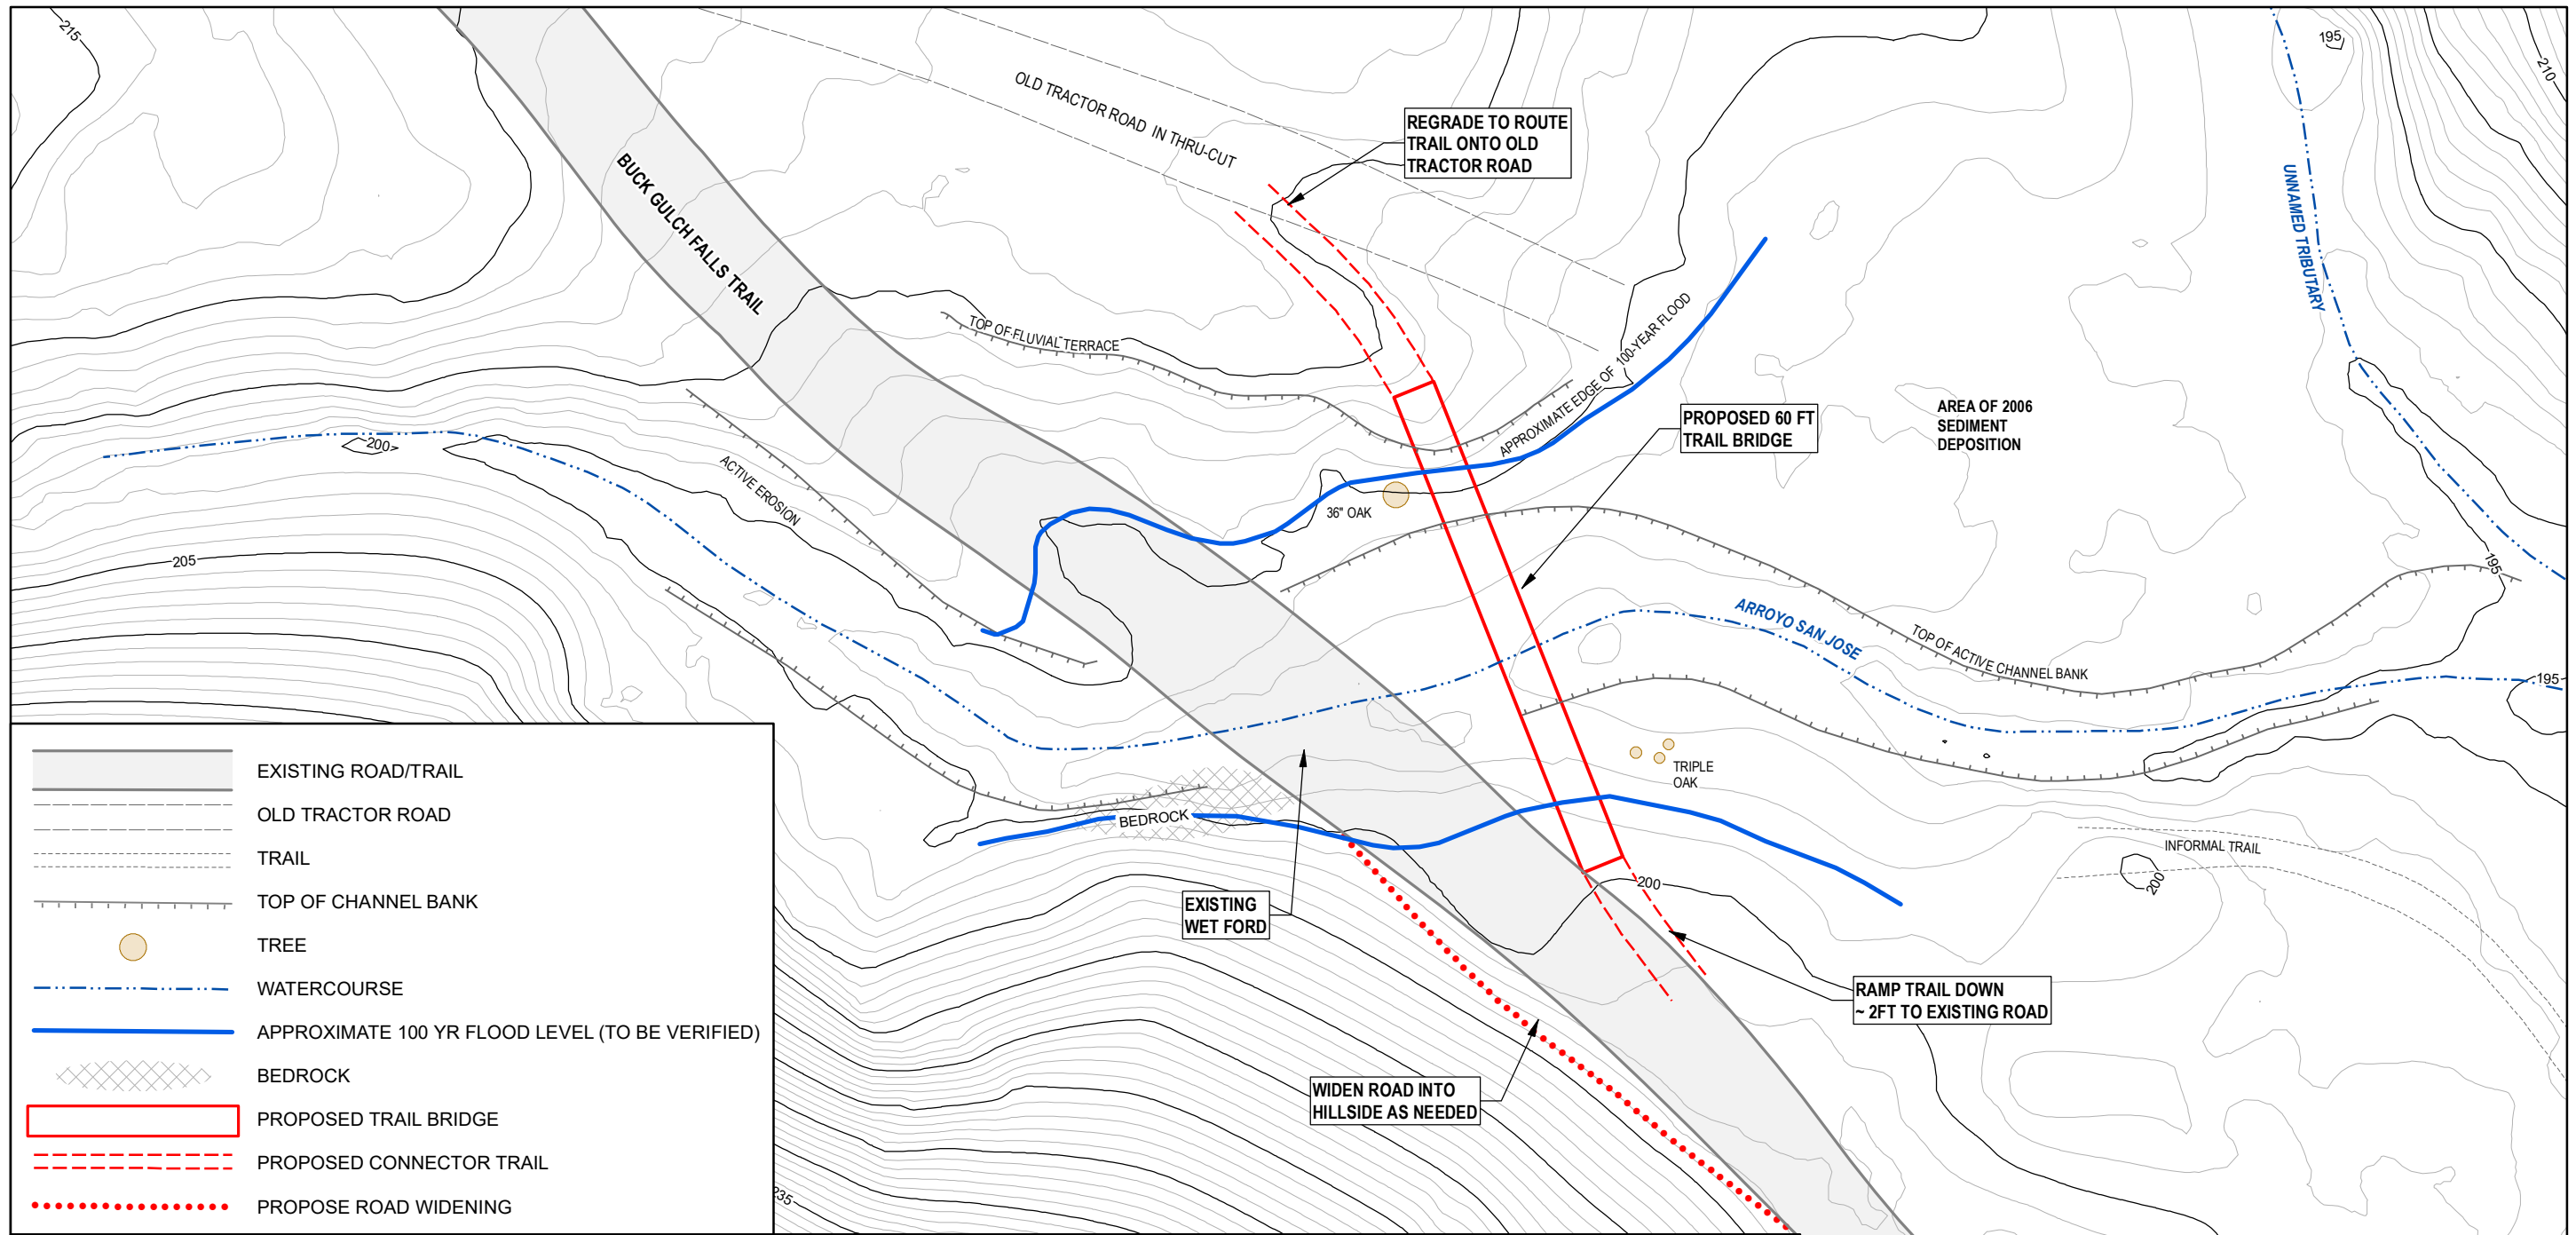
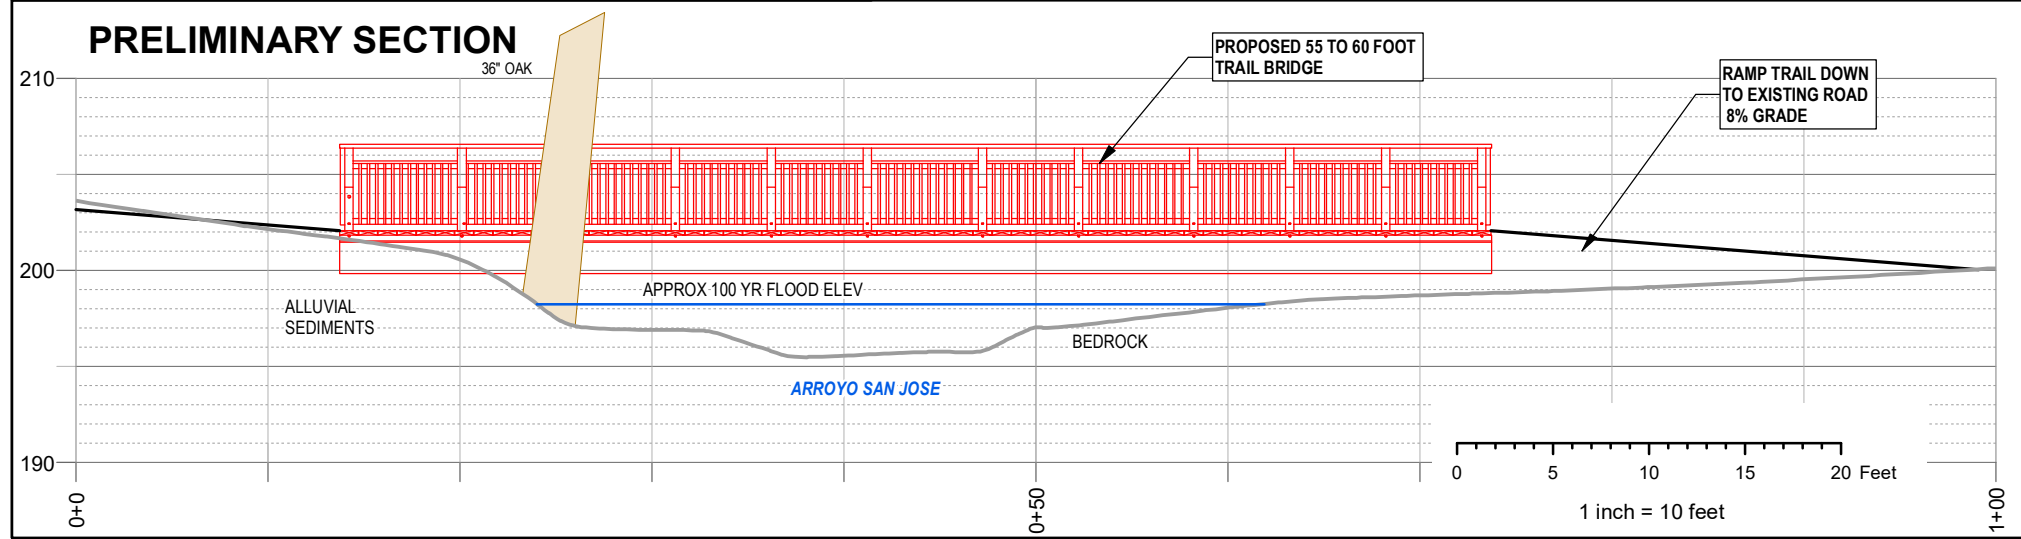
**TITLE:**  
**BUCK GULCH FALLS TRAIL BRIDGE  
 PRELIMINARY SITE MAP AND SECTION**

The left (north) bank is underlain by alluvial sediments that are much more prone to erosion. Upstream of the crossing, Arroyo San Jose makes a sharp dogleg bend with the road paralleling the stream channel on the north side of the crossing for a distance of about 80 feet. The north channel bank in this area is experiencing active erosion, which in time could undermine the road requiring the road to be relocated further away from the stream channel. At and immediately downstream of the crossing the north channel bank appears relatively stable and partially protected by a large oak tree. To minimize the risk of stream bank erosion undermining the bridge we recommend that the north bridge abutment be located on the downstream side of the large oak tree, offset a minimum of 5 feet from the top of the channel bank, and be embedded a minimum of 4 feet below the ground surface. Abutments are not shown on the preliminary map and section (Figure 2).

In our opinion, a minimum 55 to 60 foot long bridge will be required with the bridge located on the downstream side of the existing road and ford crossing as shown in Figure 2 and Photo 4. There are multiple types of bridges that can be installed including steel beam bridge with wood hand rails, similar to what the district has constructed on other projects, and prefabricated steel truss.

The south (right) bank abutment should be located just upstream of the three-trunk oak and founded into Franciscan bedrock. The north (left) should be located on the downstream side of the large oak and offset a minimum of 5 feet back from the top edge of the channel bank. This footing should be embedded a minimum of 4 feet below the ground surface. Grading and fill placement will be required on the north bridge approach where there is a thru cut to an old and now abandoned road (See Figure 2).

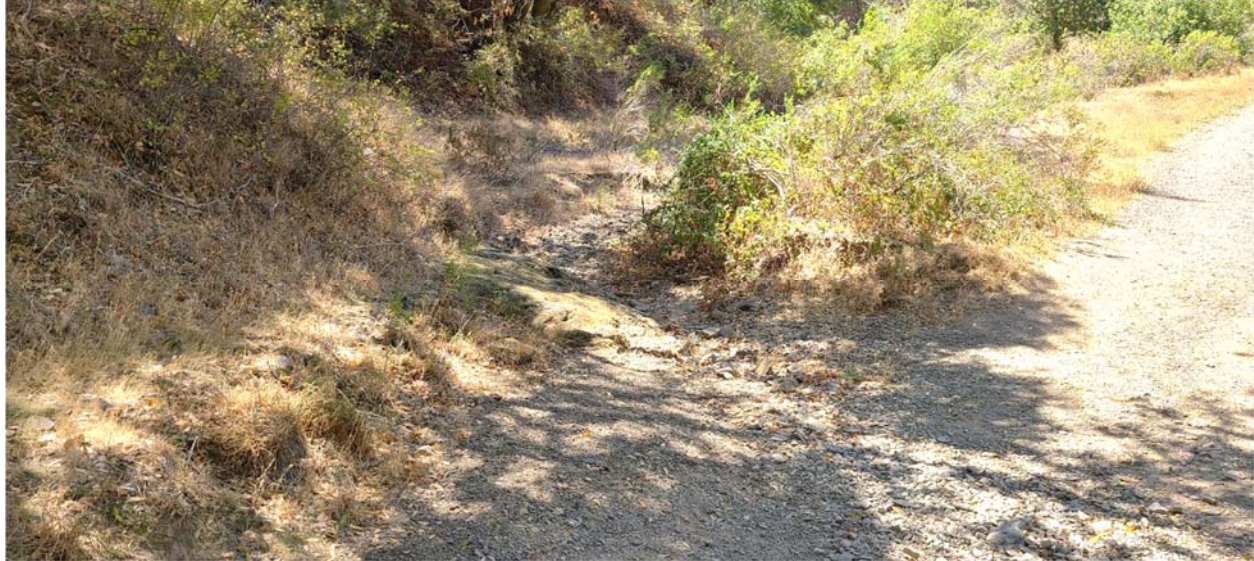
The proposed bridge site is located at the downstream end of a sharp left-hand bend in Arroyo San Jose. The right (south) bank, located at the outside of the bend, is underlain by Franciscan bedrock and does not appear to be experiencing significant erosion.

**Photo 3: Looking upstream at ford crossing**

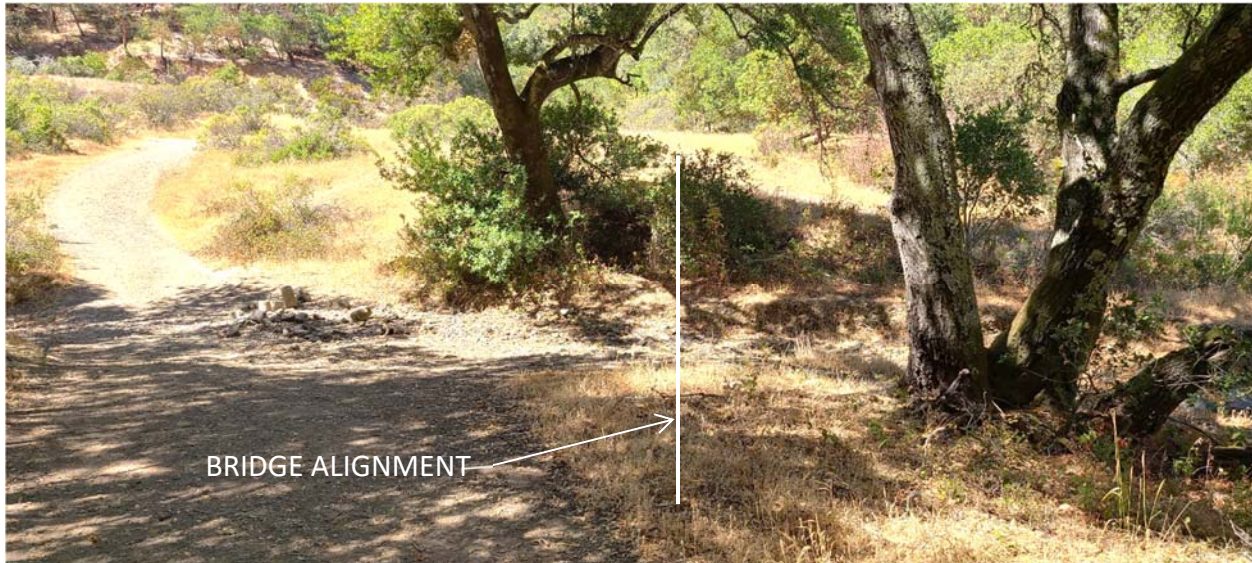
**Photo 4: Looking north across ford crossing with proposed bridge alignment highlighted**

The bottom cord of the proposed bridge should be elevated a minimum of 1 foot above the 100-year flood elevation for Arroyo San Jose. Our preliminary analysis indicates that this is about 3.75 feet above the channel bed. A more in depth hydrologic and hydraulic analysis using HEC-RAS is required to determine flood elevations more accurately.

For a level bridge the south abutment will need to be built up about 2 feet on import fill. The trail on this side of the crossing should then ramp down to join the existing road at a 5% to 8% grade. The existing road may need to be widened into the hillside slightly to accommodate the bridge and the trail that will need to ramp down to the bridge.

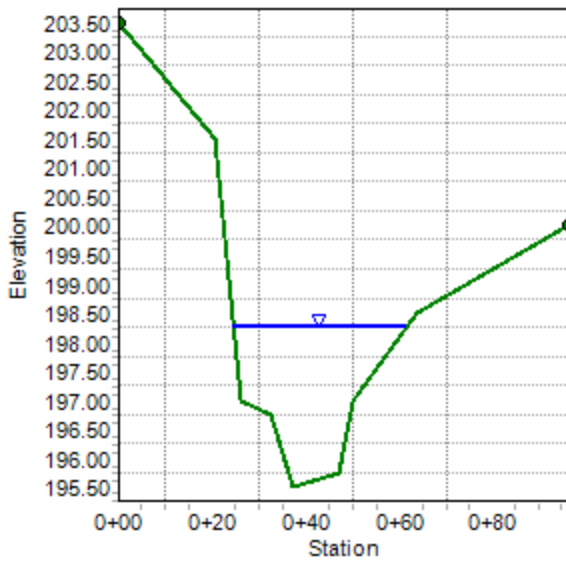
## Cross Section for Buck Gulch Falls Trail Bridge

Our preliminary analysis indicates the calculated 100-year discharge is moderately constrained within the incised channel with a maximum flow depth of about 2.75 feet. We recommend that bridge abutments be located outside the 100-year flood elevation and that the bottom of the bridge cord be elevated 1 foot above the calculated 100-year flood elevation to allow for passage of debris. It is important to note that the analysis presented here is preliminary and a more in depth hydrologic and hydraulic analysis using HEC-RAS is recommended.

Hydraulic Radius	1.55	ft
Top Width	36.78	ft
Normal Depth	2.75	ft
Critical Depth	2.23	ft
Critical Slope	0.06760	ft/ft
Velocity	4.49	ft/s
Velocity Head	0.31	ft
Specific Energy	3.06	ft
Froude Number	0.63	
Flow Type	Subcritical
