## PCI ECOLOGICAL

### MEMO

**Subject:** Buck Gulch Falls Accessible Trail Feasibility Study: Supplemental Study

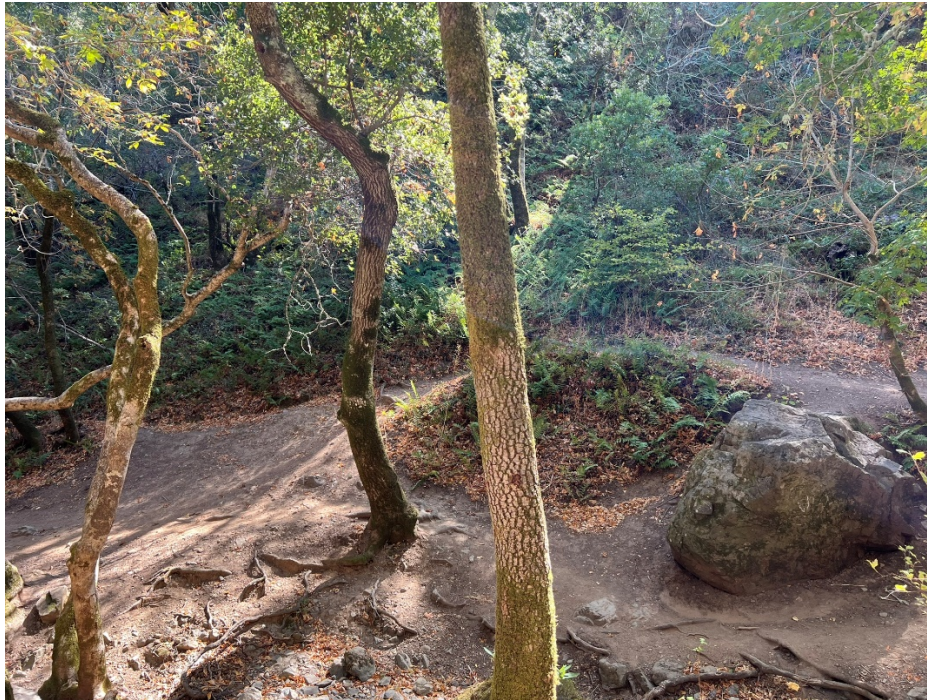
Photo 1. View from across the creek looking at the existing boulder and social trail near the waterfall viewing area

Below is a photograph of the current conditions at the boulder near the waterfall, along with an example image of a switchback trail.

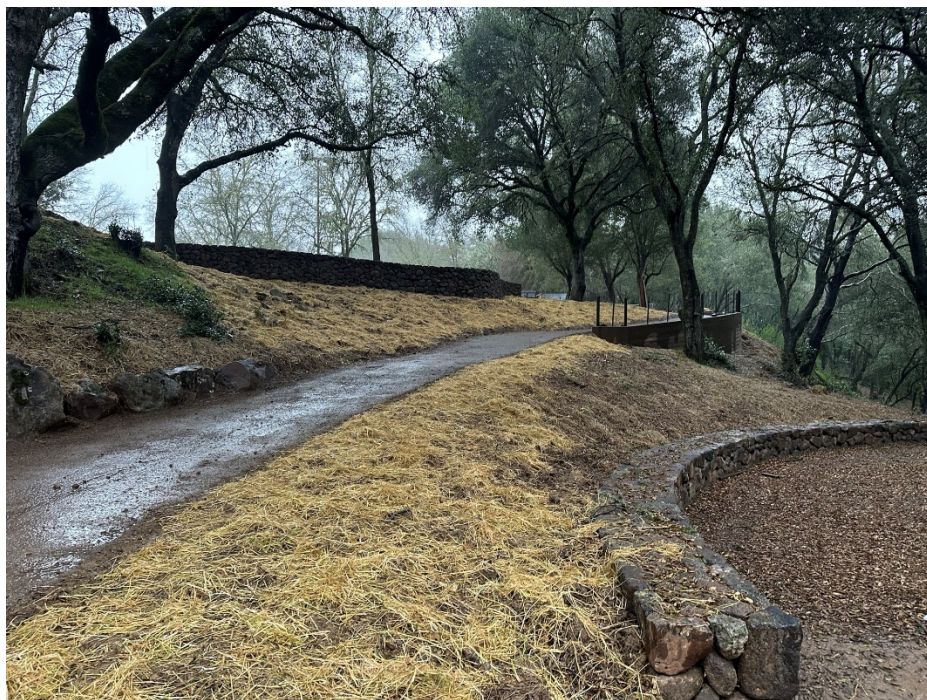
Photo 2. Example of a switchback trail in construction from Fitch Mountain

This alternative route would maintain the creek's integrity while guiding users to an elevation that is close to the viewing area. The pathway would follow a gradual ascent through a series of switchbacks, with inclines between 6% and 8%. It would also include approximately 110 feet of retaining wall, with heights varying from 2 to 5 feet, facilitating a comfortable and efficient ascent to the designated elevation for accessing the waterfall viewing area. To ensure safety and regulatory compliance, handrails would be necessary along the switchback ramp.
