## Buck Gulch Falls

# Accessible Trail Feasibility Study

Ignacio Valley Preserve  
Marin County, CA  
December 2024

PCI Ecological  
103 Morris Street, Suite A-5  
Sebastopol, CA 95472

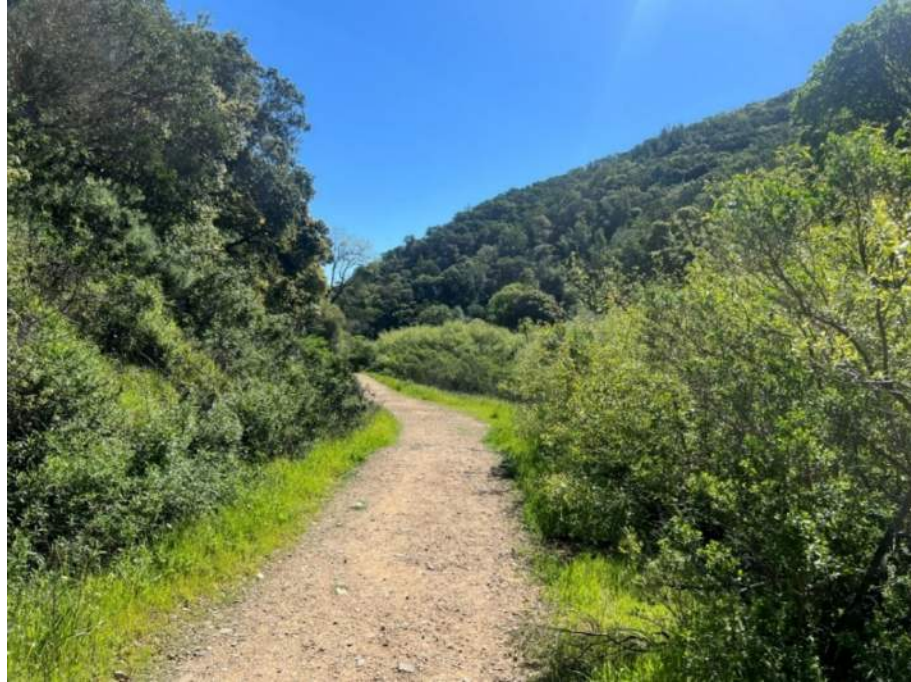
*Photo 1. Existing trail near beginning of study area looking east*

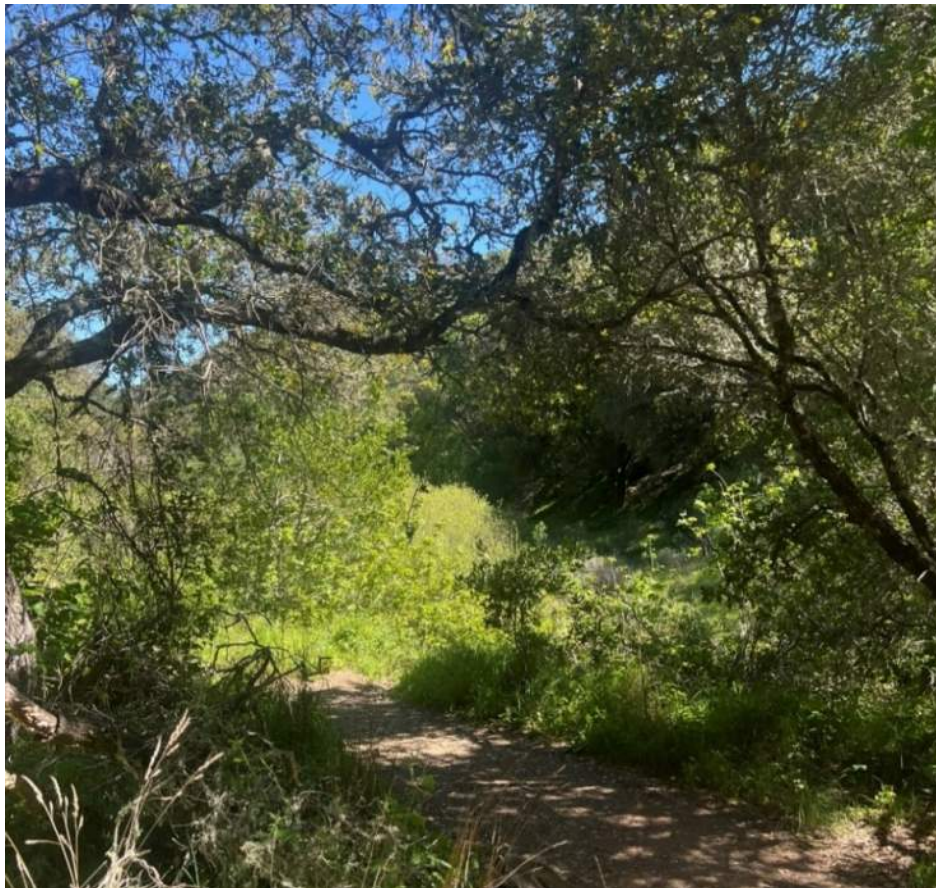
*Photo 2. Overhanging tree limbs in Trail Segment 1*

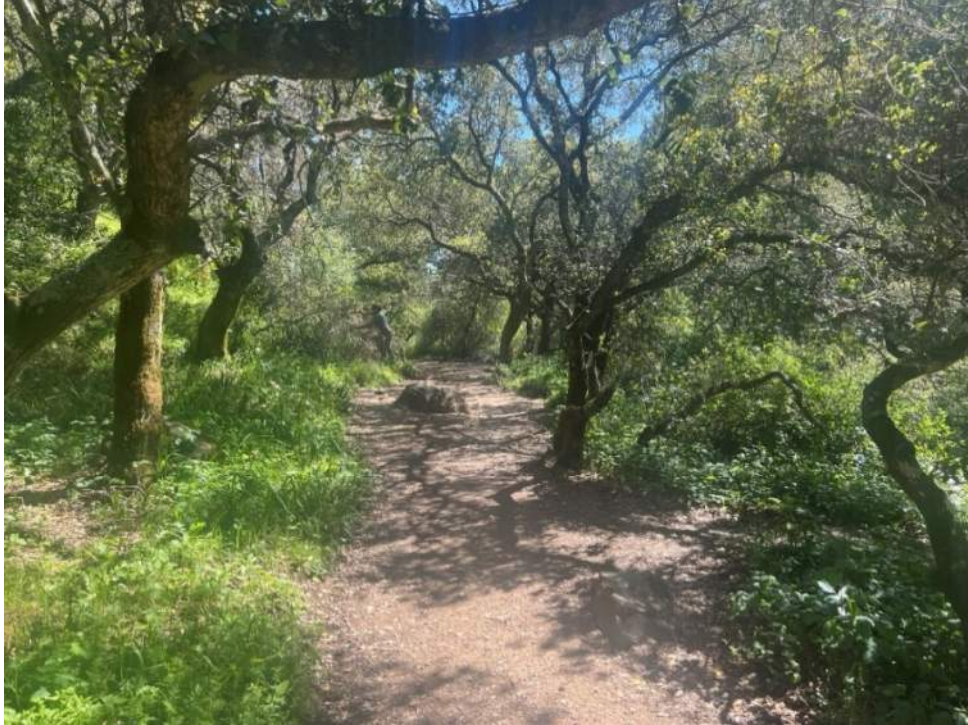
*Photo 3. Boulder within trail in Segment 1 to be worked around*

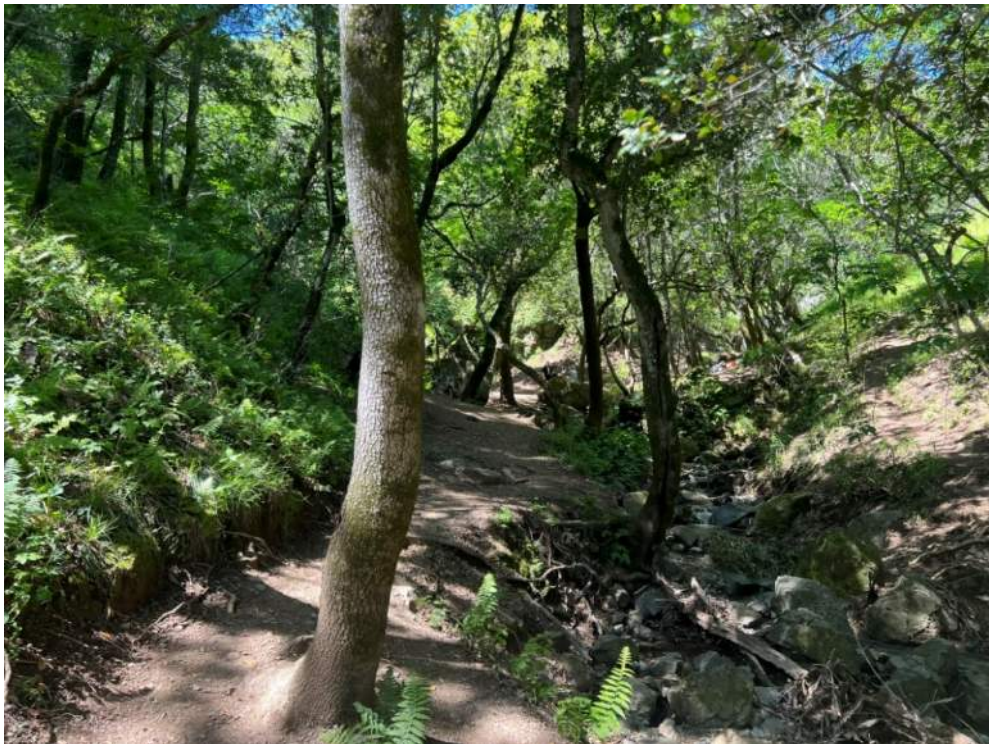
*Photo 4. Existing trees, slope and creek adjacent to waterfall in Segment 2*

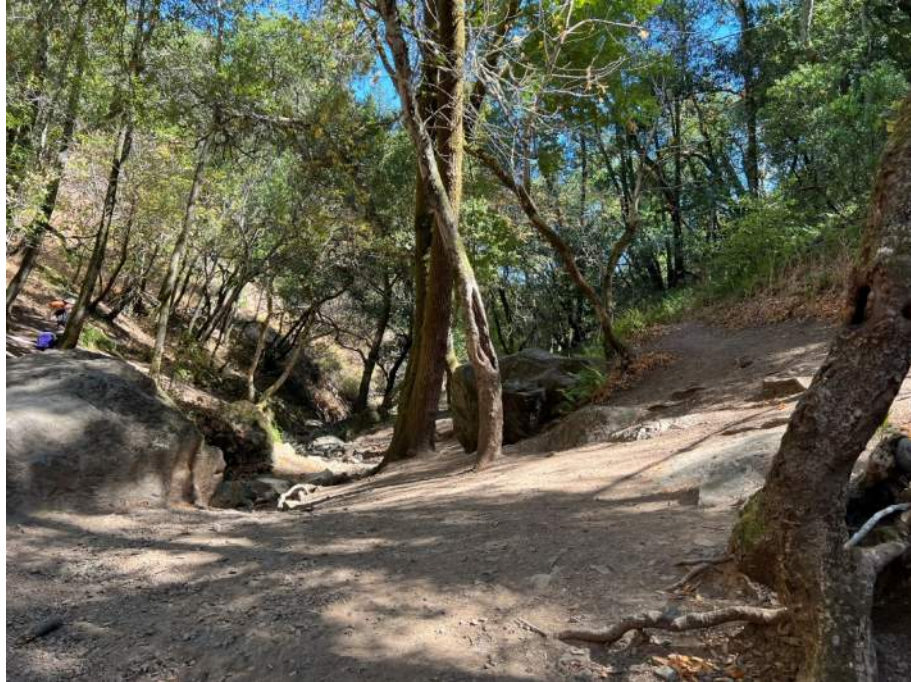
*Photo 5. Approach to Waterfall Viewing Area looking upstream in Segment 2*

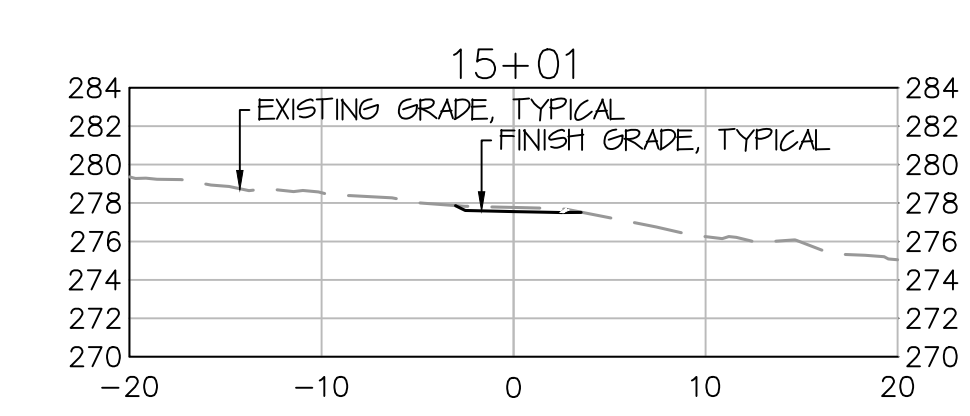
**SEGMENT 1 (A & B)**

**SEGMENT 1: Beginning of Study Area to Proposed Bridge**  
 Alternative A: Creek Trail to Proposed Bridge with Walls  
 Alternative B: Creek Trail to Proposed Bridge without Walls

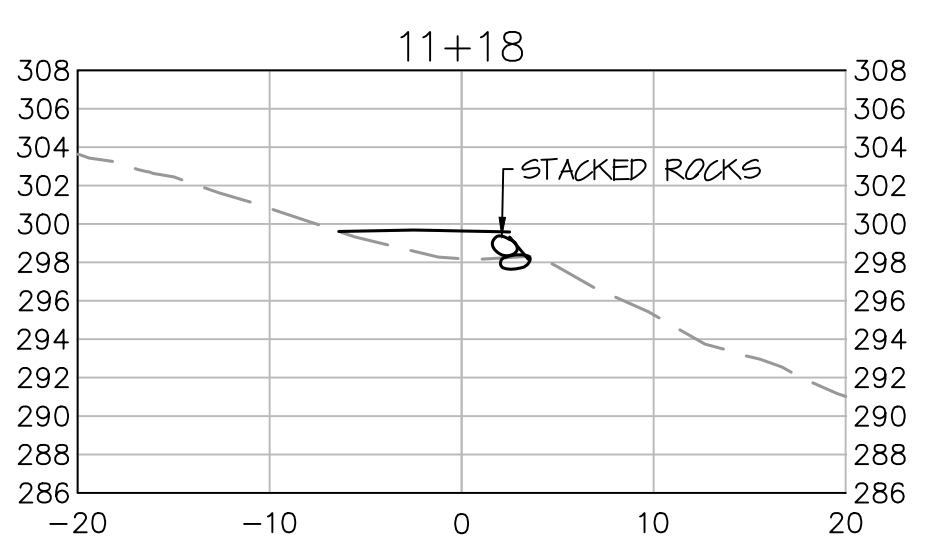
**BUCK GULCH FALLS TRAIL PROFILE**

**SEGMENT 1: Beginning of Study Area to Proposed Bridge**  
 Alternative A: Creek Trail to Proposed Bridge with Walls  
 Alternative B: Creek Trail to Proposed Bridge without Walls

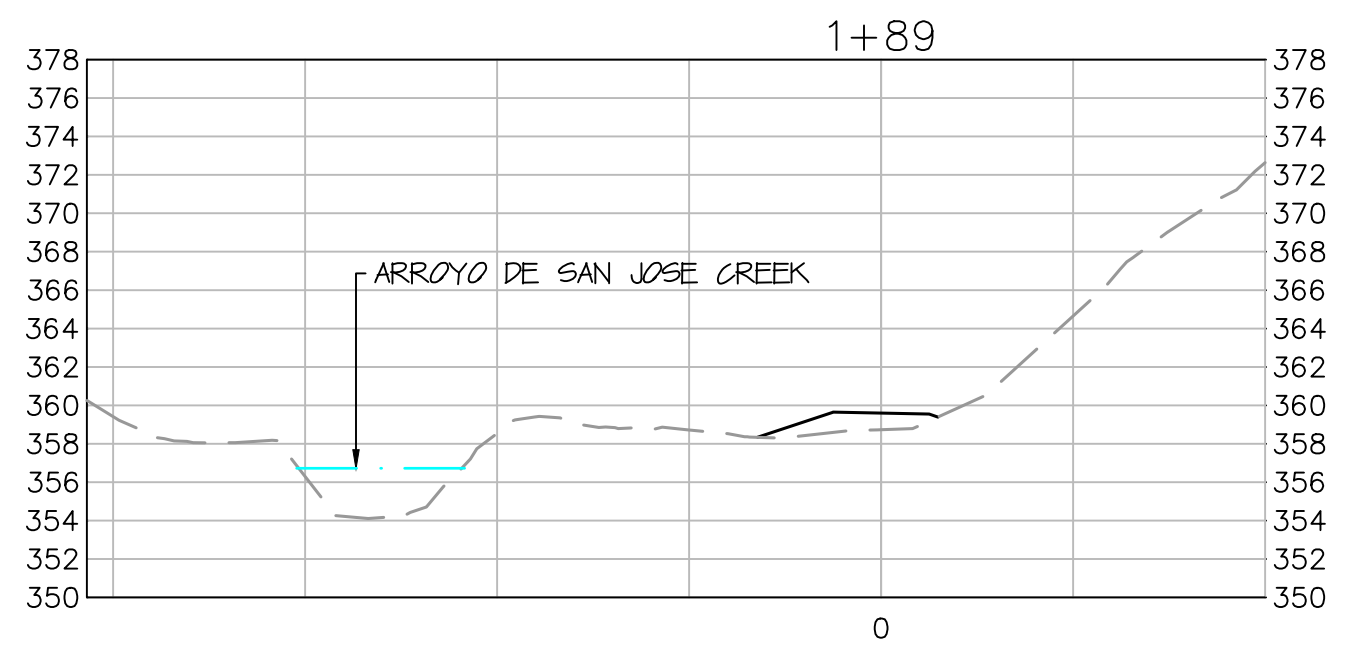
SHEET  
**5**  
 OF 7

**SEGMENT 2: Proposed Bridge to Waterfall Viewing Area**  
 Alternative A: Creek Trail with Boardwalk and Stairs

**BUCK GULCH FALLS TRAIL**  
**SEGMENT 2 ALTERNATIVE A**
